**National Highway
Traffic Safety
Administration**

194-00

Case Vehicle (A): 1998 Toyota
Type: Camry LE, 4-door sedan
Driver: 37-year-old female
CDC: 11-FDEW-1, 03-RYEW-2

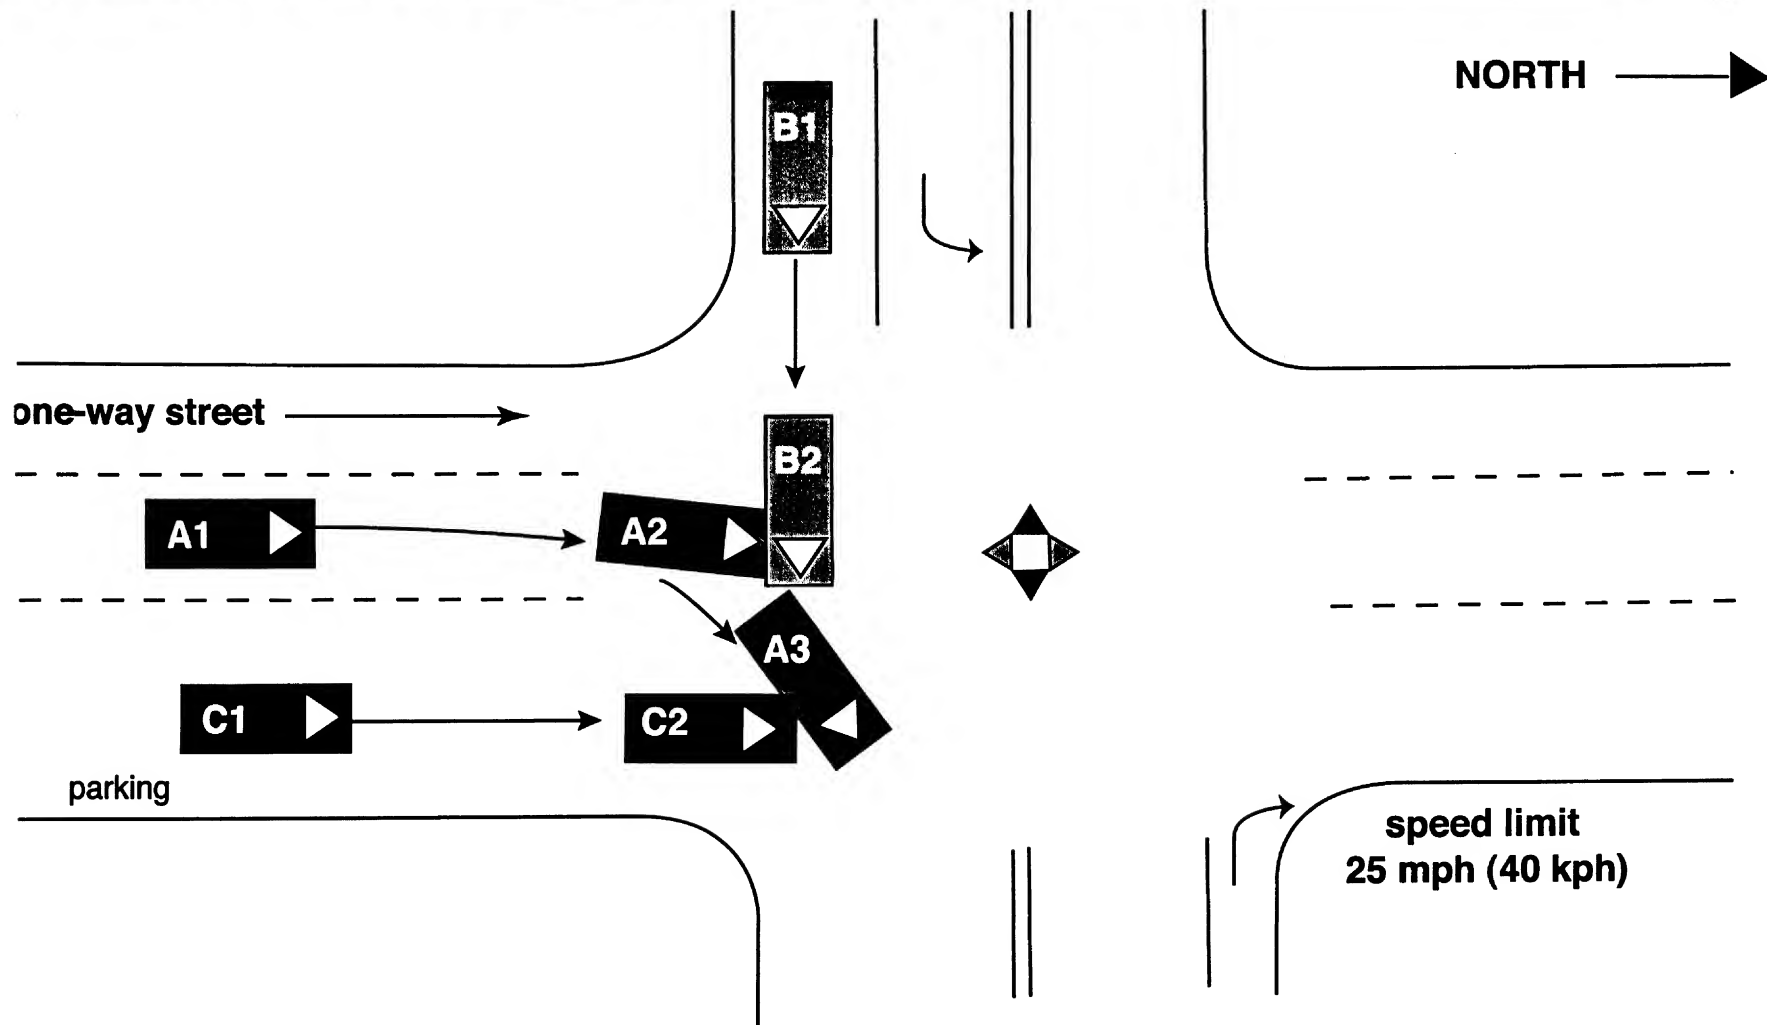
ACCIDENT SCHEMATIC

(Slides 1, 2) On a clear, dry day, case vehicle (A) was traveling north at a driver-estimated speed of 35 mph (56 kph) in the center lane of a three-lane, one-way asphalt road, and was approaching an intersection. Vehicle (B) was traveling east at an unknown speed in the through lane of the intersecting three-lane road. As case vehicle (A) began to enter the intersection, the driver of vehicle (B) proceeded into the intersection. The driver of case vehicle (A) braked and steered to the right, but was unable to avoid striking vehicle (B) in the right side with its front. After the impact, case vehicle (A) rotated clockwise and crossed the lane line into the right northbound lane. Vehicle (C), that was traveling in the right northbound lane, was unable to avoid striking the right side of case vehicle (A) with its front.

ACCIDENT DESCRIPTION: CASE VEHICLE (A) WAS TRAVELING CASE VEHICLE (A): 1998 TOYOTA CAMRY Q
NORTH AT A DRIVER-ESTIMATED SPEED OF 35MPH (56KPH) OTHER VEHICLE (B): 1988 LINCOLN TOWN CAR A
IN THE CENTER LANE. VEHICLE (B) WAS TRAVELING EAST THIRD VEHICLE (C): 1989 FORD THUNDERBIRD
AND WAS APPROACHING THE INTERSECTING ROAD. AS CASE VEHICLE (A) ENTERED THE
INTERSECTION, IT STRUCK THE RIGHT SIDE OF VEHICLE (B). AFTER THE IMPACT, CASE
VEHICLE (A) ROTATED CLOCKWISE AND WAS STRUCK IN THE RIGHT SIDE BY VEHICLE
(C), WHICH WAS NORTHBOUND IN THE RIGHT LANE.

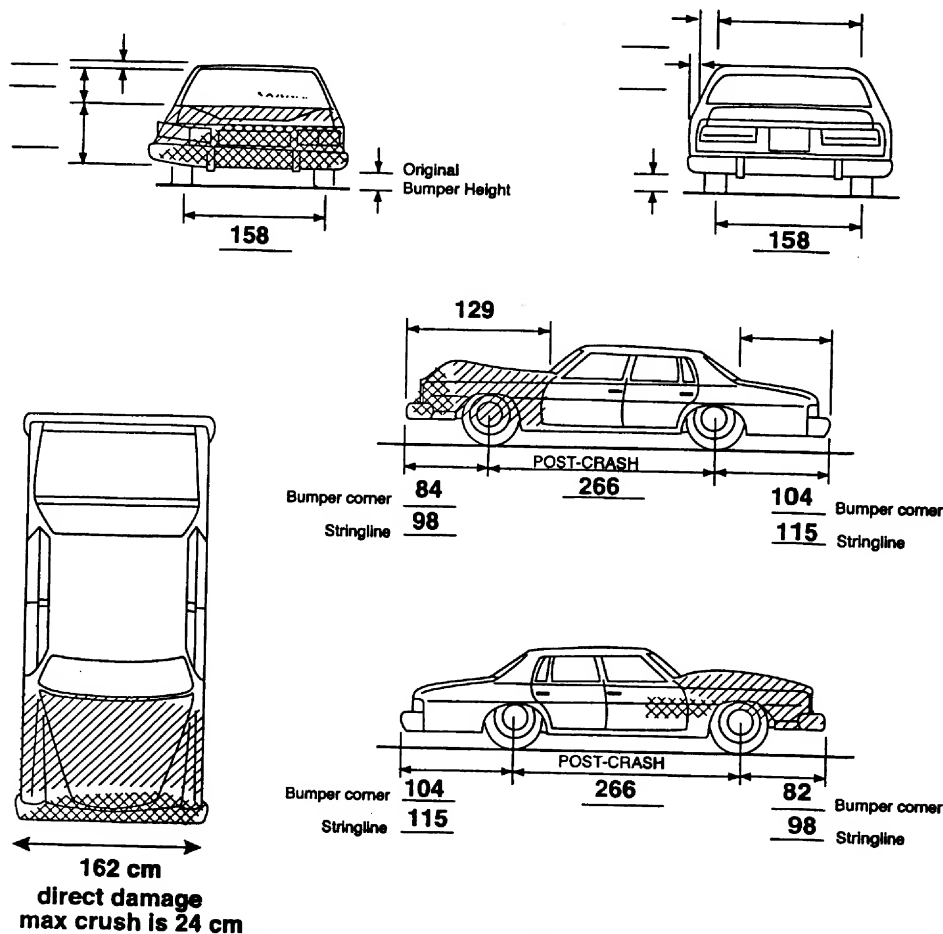
(Slides 3, 4) The direct damage to case vehicle (A) from the frontal impact began at the left-front bumper corner and extended 162-cm across the entire front bumper. The maximum crush was 24 cm to the center portion of the front bumper. The direct damage from the right-side impact began at the right-front wheel and extended 106-cm rearward along the fender and right-front door panel. The maximum crush was 7 cm to the right-front door.

Wheelbase	<u>266</u> cm	Front Overhang	<u>098</u> cm
Curb Weight	<u>1415</u> kg	Rear Overhang	<u>115</u> cm
Average Track Width	<u>153</u> cm	Undeformed End Width (UEW)	<u>162</u> cm
Overall Length	<u>479</u> cm	Engine Displacement	<u>1.8</u> L
Overall Width (OAW)	<u>178</u> cm	Engine: # of Cylinders	<u>04</u>

Direct Damage Length (DDL) 162 cm

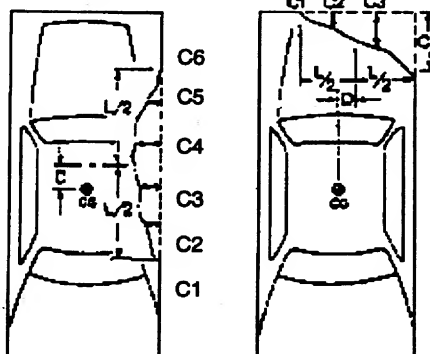
Specific Impact No.	Location of Direct Damage	Location of Field L
1	BEGINS AT LFBC 132 CM	BC TO BC
2	BEGINS AT RE WHEEL 106	N/A

MAX CRUSH FOR FRONTAL IMPACT IS 19cm FROM C2

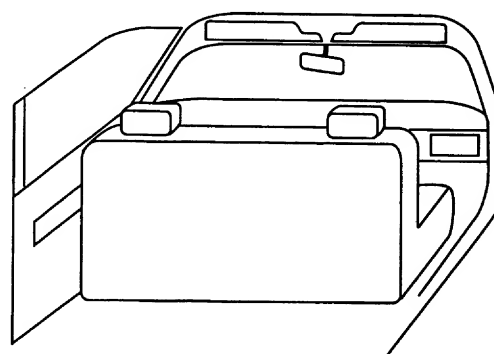
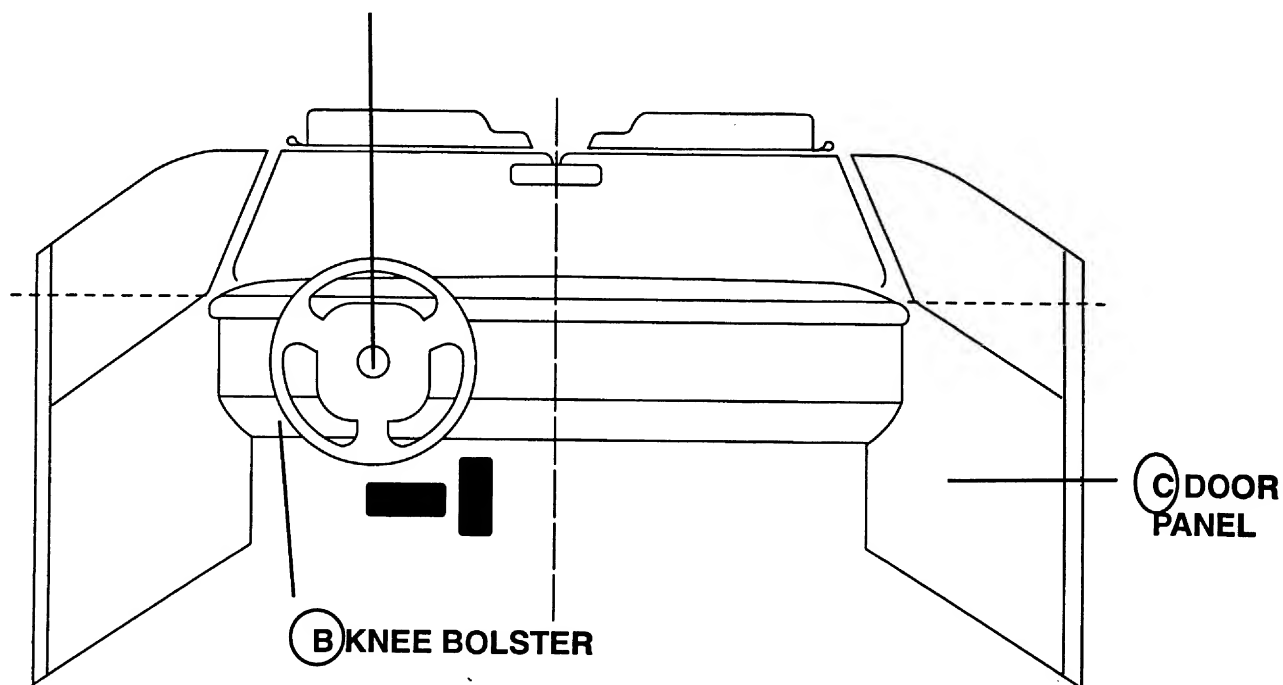
DR BELT: UP-POSITION ON B-PILLAR.
WEBBING LOCKED IN EXTENDED
POSITION. MARKS ON D-RING AND
SHOULDER-BELT WEBBING
DEFINITE USE.

RF BELT: UP-POSITION ON B-PILLAR.
WEBBING LOCKED IN EXTENDED
POSITION. MARKS ON D-RING AND
SHOULDER-BELT WEBBING
DEFINITE USE.

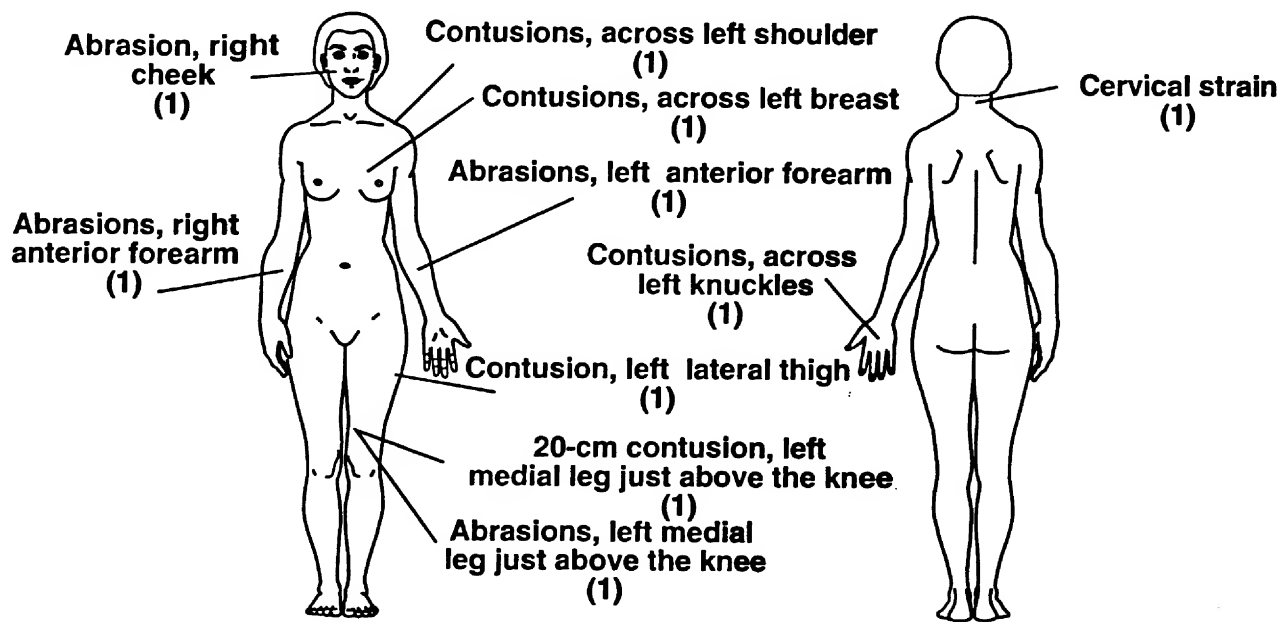
INDICATE LOCATION OF INJURIES.

Injury Description	A.I.S.	Injury Source		
		Definite	Probable	Possible
Cervical strain	1		Impact force	
Abrasion, right cheek	1	Airbag		
Contusions, across left shoulder	1	Shoulder belt webbing		
Contusions, across left breast	1	Shoulder belt webbing		
Abrasions, left anterior forearm	1	Airbag		
Abrasions, right anterior forearm	1	Airbag		
Contusions, across left knuckles	1			Instrument panel, airbag fling into unknown interior object
20-cm contusion, left medial leg just above the knee	1		Knee bolster	
Abrasions, left medial leg just above the knee	1		Knee bolster	
Contusion, left lateral thigh	1			Side door panel
<u>Maximum A.I.S. Level</u>	<u>1</u>			
<u>Injury Severity Score</u>	<u>2</u>

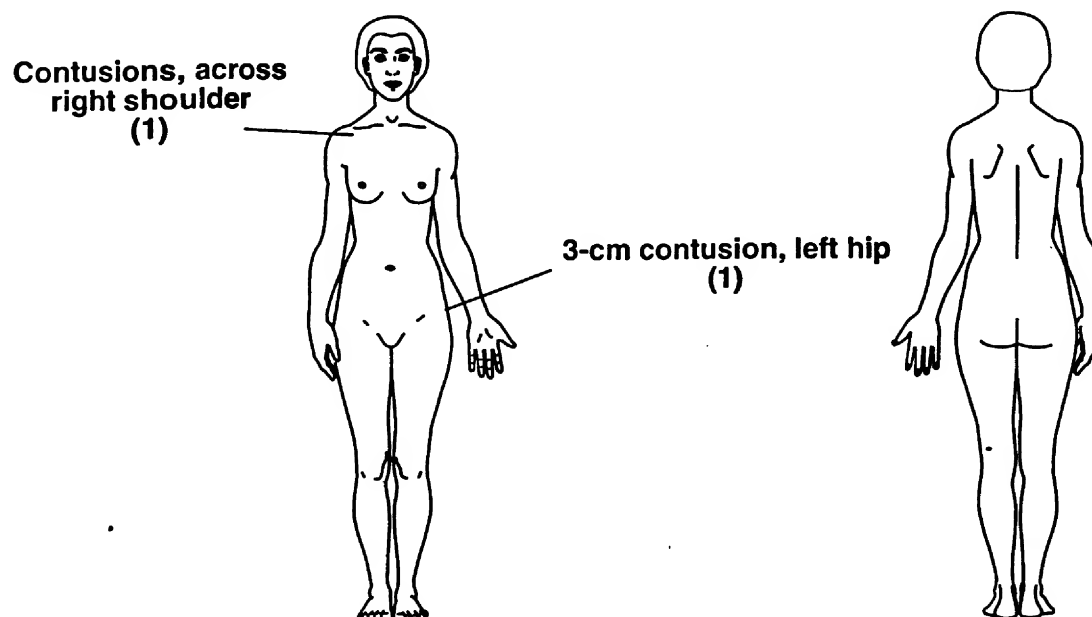
INDICATE LOCATION OF INJURIES.

Injury Description	A.I.S.	Injury Source		
		Definite	Probable	Possible
Contusions, across right shoulder	1	Shoulder belt webbing		
3-cm contusion, left hip	1		Buckle assembly	
<u>Maximum A.I.S. Level</u>	<u>1</u>			
<u>Injury Severity Score</u>	<u>1</u>
